# **Intel® Celeron™ Processor Specification Update**

Release Date: February 1999

Order Number: 243748-012

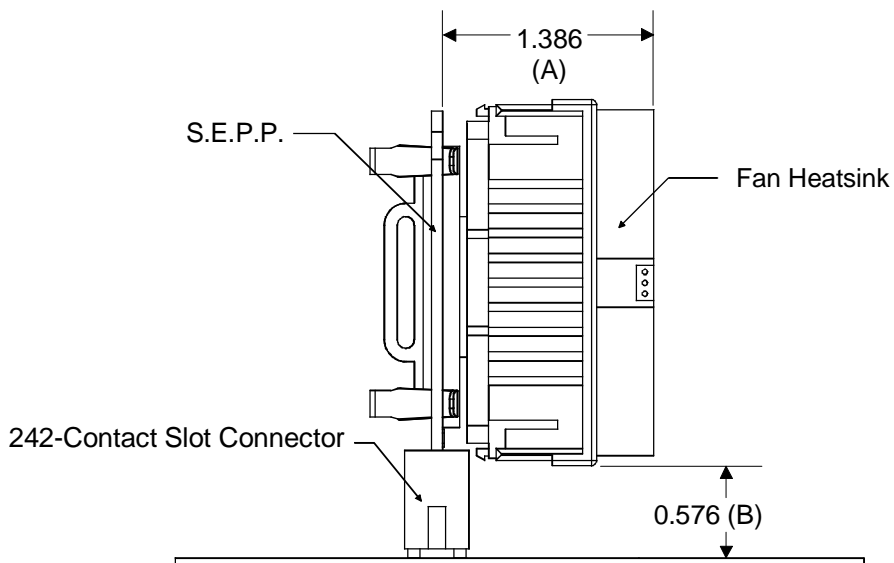
**Figure 20. Side View Space Requirements for the Boxed Processor**

Figures 20, 21, and 22, and Table 34 of Section 6.2 of the *Intel® Celeron™ Processor* datasheet show incorrect fan heat sink dimensions for the boxed Intel Celeron processor. The correct figures and table are shown below.

The maximum depth of the fan heat sink to the processor substrate should be 1.386", not 1.291" max. The minimum height clearance above the baseboard should be 0.576", not 0.485". The fan shroud height should be 2.02" and 4.74", respectively, not 2.19" max. and 4.90" max. Figure 22 should show reference "G" for the minimum airflow keepout zone from the inlet of the fan heat sink, and reference "F" for the minimum airflow keepout zone from the ends of the fan heat sink.
